Philip F. Henshaw, 811 East 17th Ave., Denver Colorado

The motivation for the research activity this report represents is primarily derived from the clear need for quality intuitive understanding of micro-climate dynamics in all sectors of the solar design community. In pursuit of this I presently concentrate on broad questions of pure science and architectural design opportunities. I am particularly interested in questions because the multiplicity of solar and conservation 'answers' seems to be doing some harm to the development of honest quality, and because I feel that there are not enough good hypotheses.

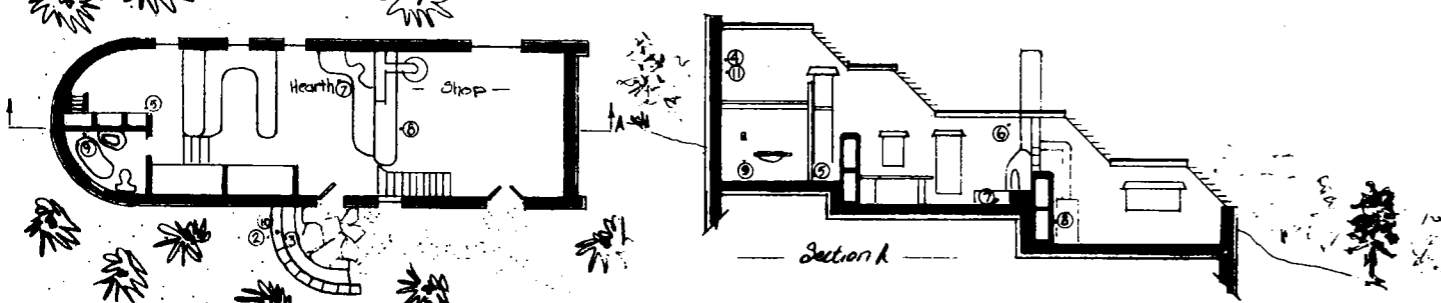
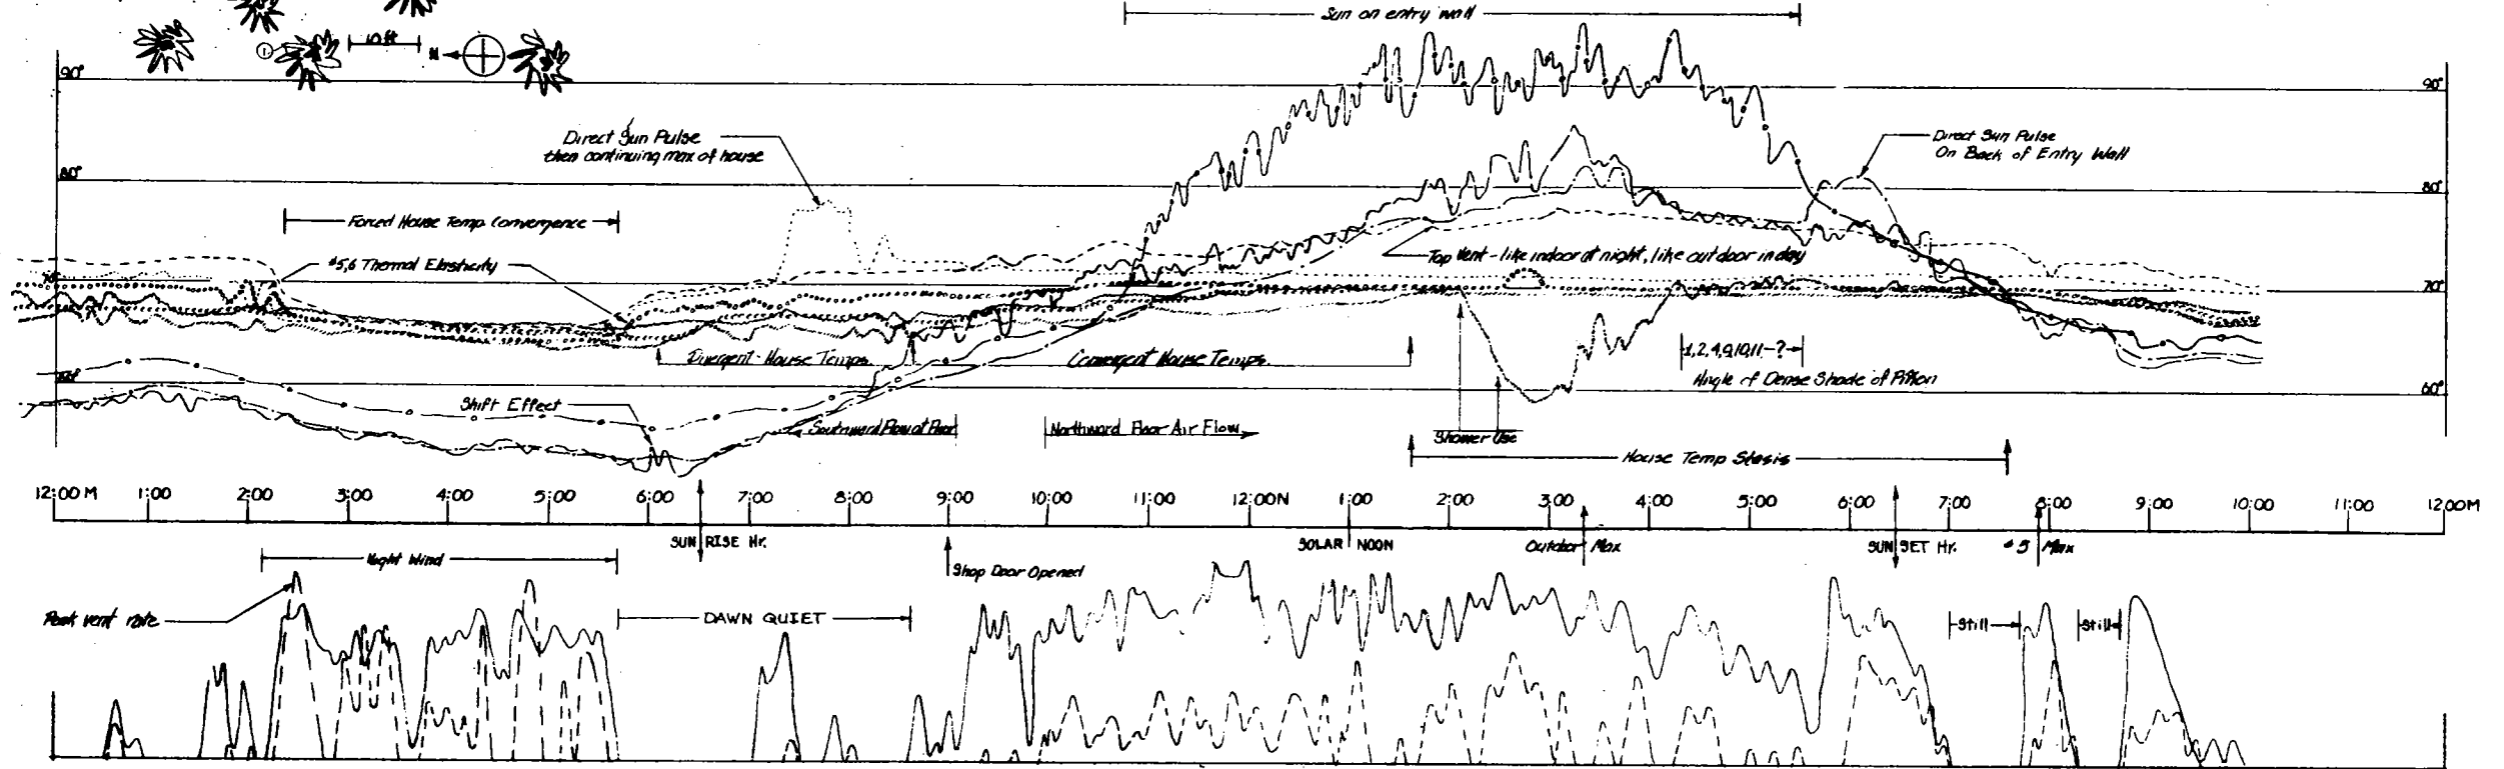
August 1977 Sante Fe, New Mexico - Adobe, Direct Gain Solar House, Sunny Day

- 1 ——— Outside Temp. — behind tree
- 2 ——— " " — behind entry wall
- 3 ——— " " — face of entry wall
- 4 - - - - - Inside Temp — top vent
- 5 ······· " " — below loft
- 6 ······· " " — above hearth
- 7 ······· " " — below hearth
- 8 ······· " " — north wall of shop
- 9 ······· " " — bathroom over tub
- 10 ——— Outside Wind — Top of entry wall
- 11 ——— Inside " — Top vent

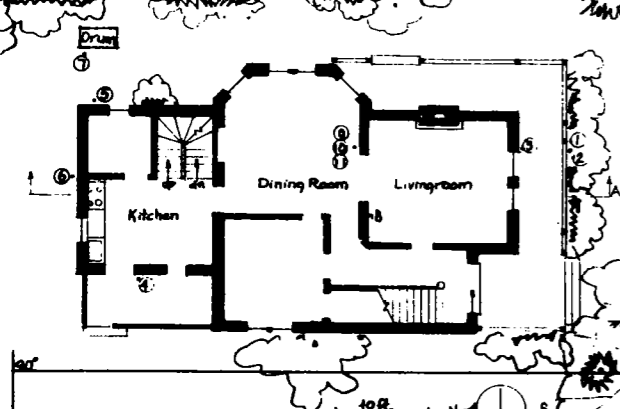
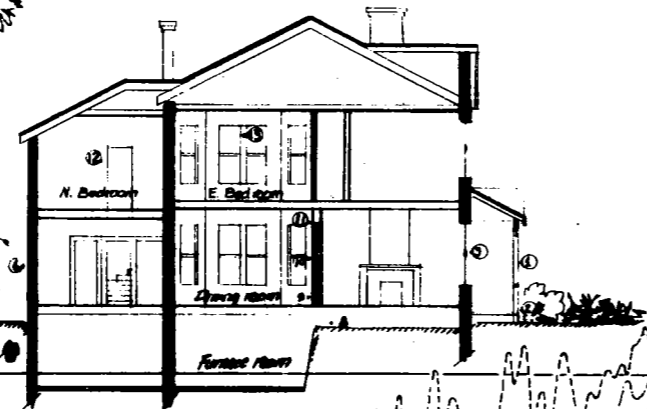
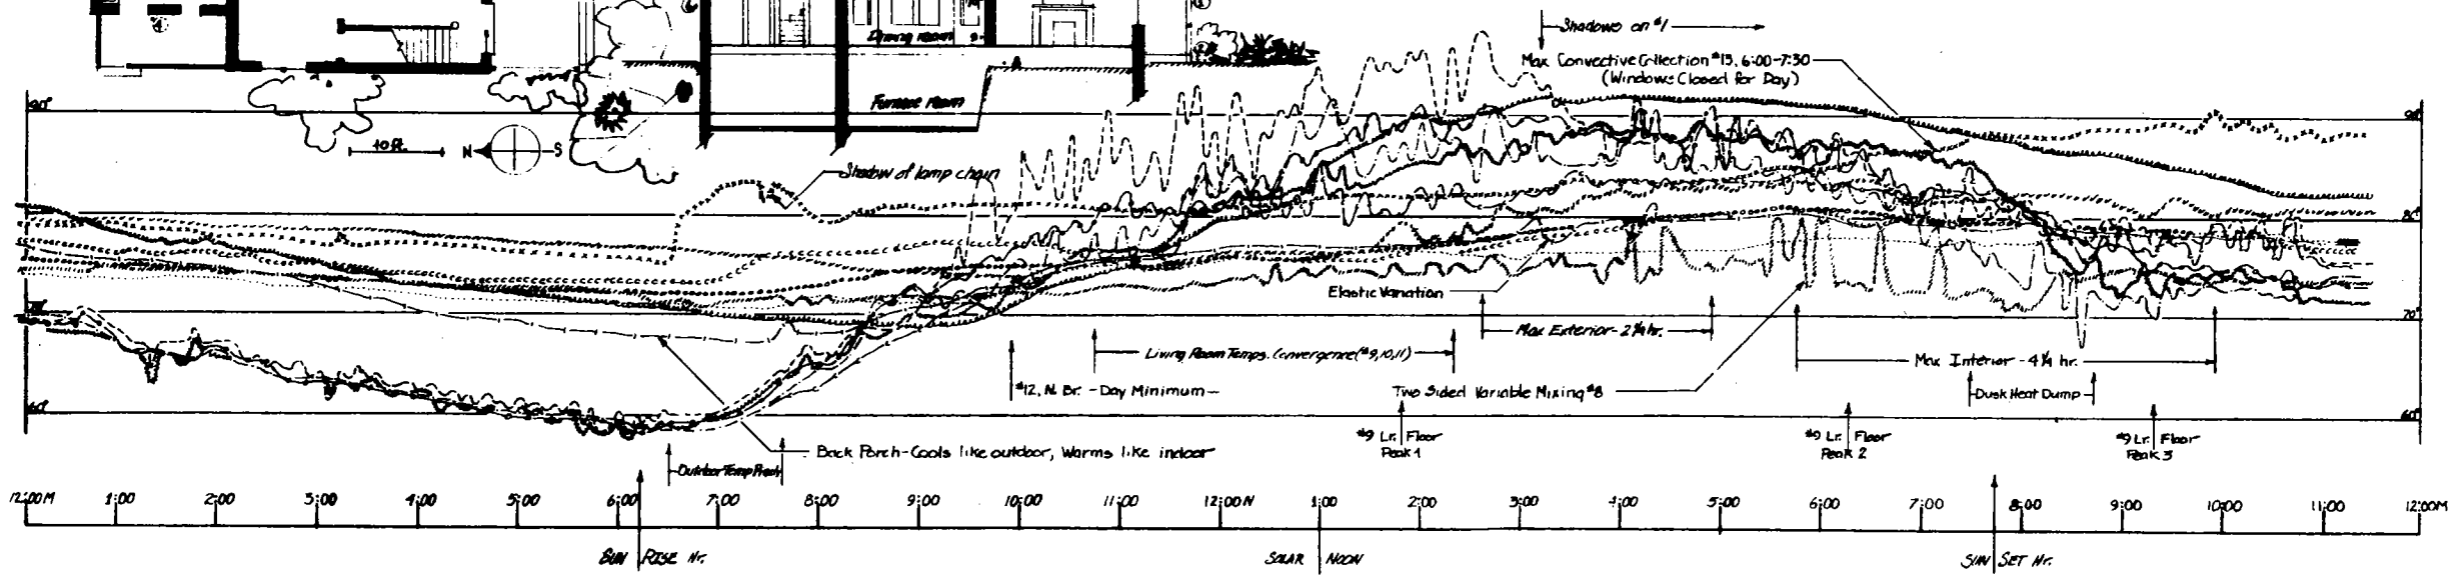
August 1977 - Denver Colorado - South Facing Brick Victorian House - Sunny Day -

- 1 - - - - - Outdoor Temp. - Front of Porch in Sun
- 2 - - - - - " " " - Under Front Bushes
- 3 - - - - - " " " - Front Wall in Shade of Porch
- 4 - - - - - " " " - Back Porch by Kitchen Door
- 5 - - - - - " " " - Rear of E. Wall w/ Foam Cover Insul.
- 6 - - - - - " " " - 3" off N. Wall
- 7 - - - - - " " " - On W Side of Drum w/ Foam Cover Insul.
- 8 - - - - - Inside Temp - Sub-floor of Lr.
- 9 - - - - - " " " - On Dining Rim Floor
- 10 - - - - - " " " - @ 5' Above #9
- 11 - - - - - " " " - @ 9' Above #9 (10'-6" Ceiling)
- 12 - - - - - " " " - North Bedroom
- 13 - - - - - " " " - East Bedroom

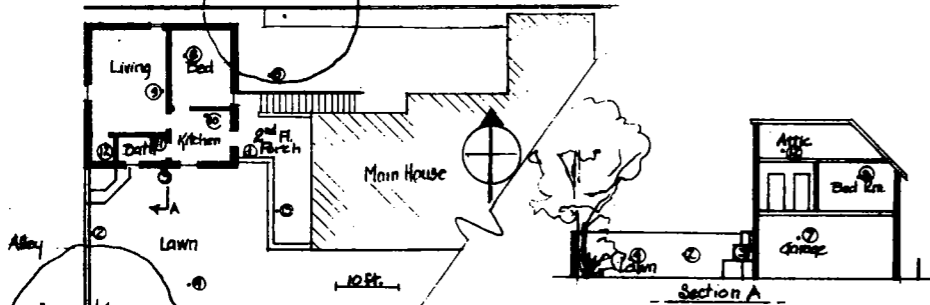
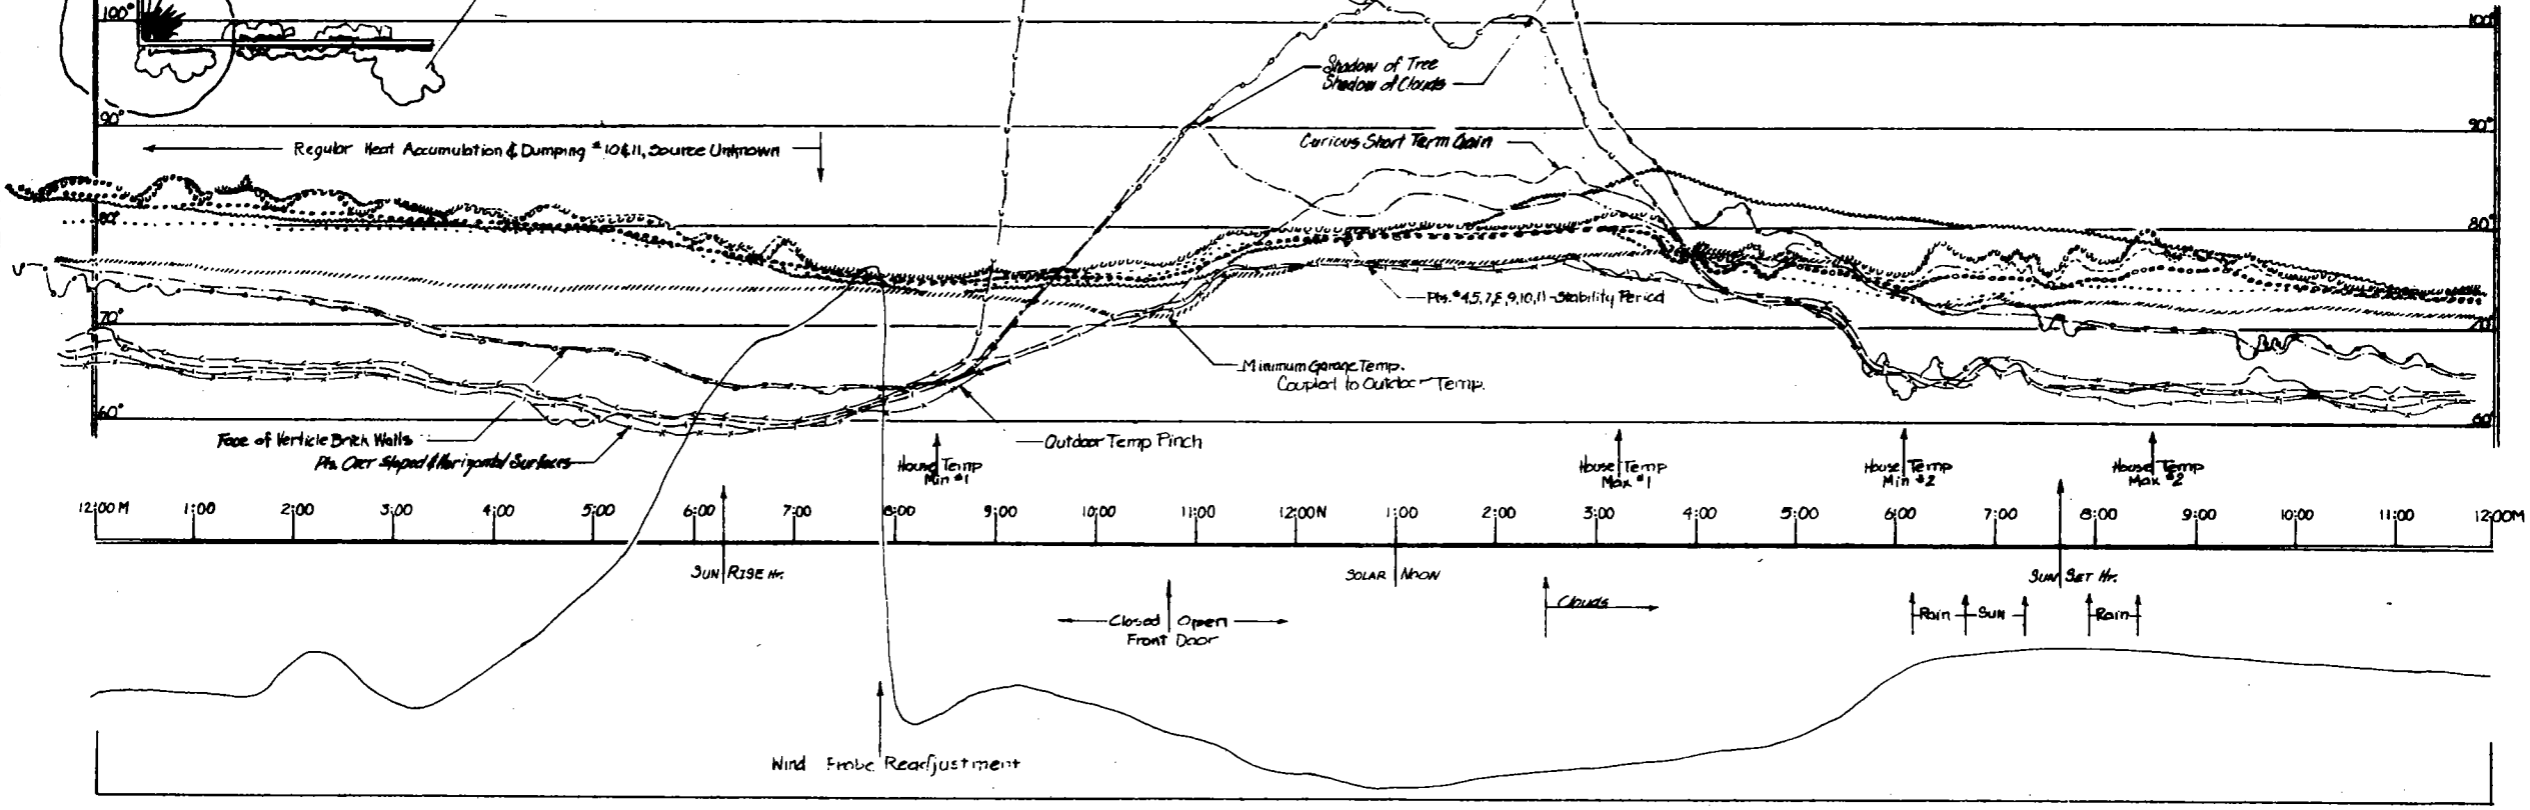
August 1977 - Denver, Colorado - Two Story Brick Carriage House - P.M. Clouds, 6:30 Shower

150°F
 $\Delta T = 60^\circ$
 Sun ESE @ 50° Elevation

- 1 --- Outdoor Temp. - On 2nd fl. Entry Deck - Shaded
- 2 --- " " - E. Side of W. Garden Wall @ 4' el.
- 3 --- " " - S. Side of S. Wall of House @ 5' el.
- 4 --- " " - On 3' Pole in Lawn
- 5 --- " " - Sheltered Driveway E. of House
- 6 --- " " - E. Facing Roof Slope
- 7 / / / / / Indoor Temp - In Garage
- 8 " " - Bedroom
- 9 " " - Livingroom
- 10 u u u u u " " - Kitchen
- 11 " " - Bathroom
- 12 / / / / / " " - Attic 1' Above Ceiling
- 13 --- Average Wind on Porch

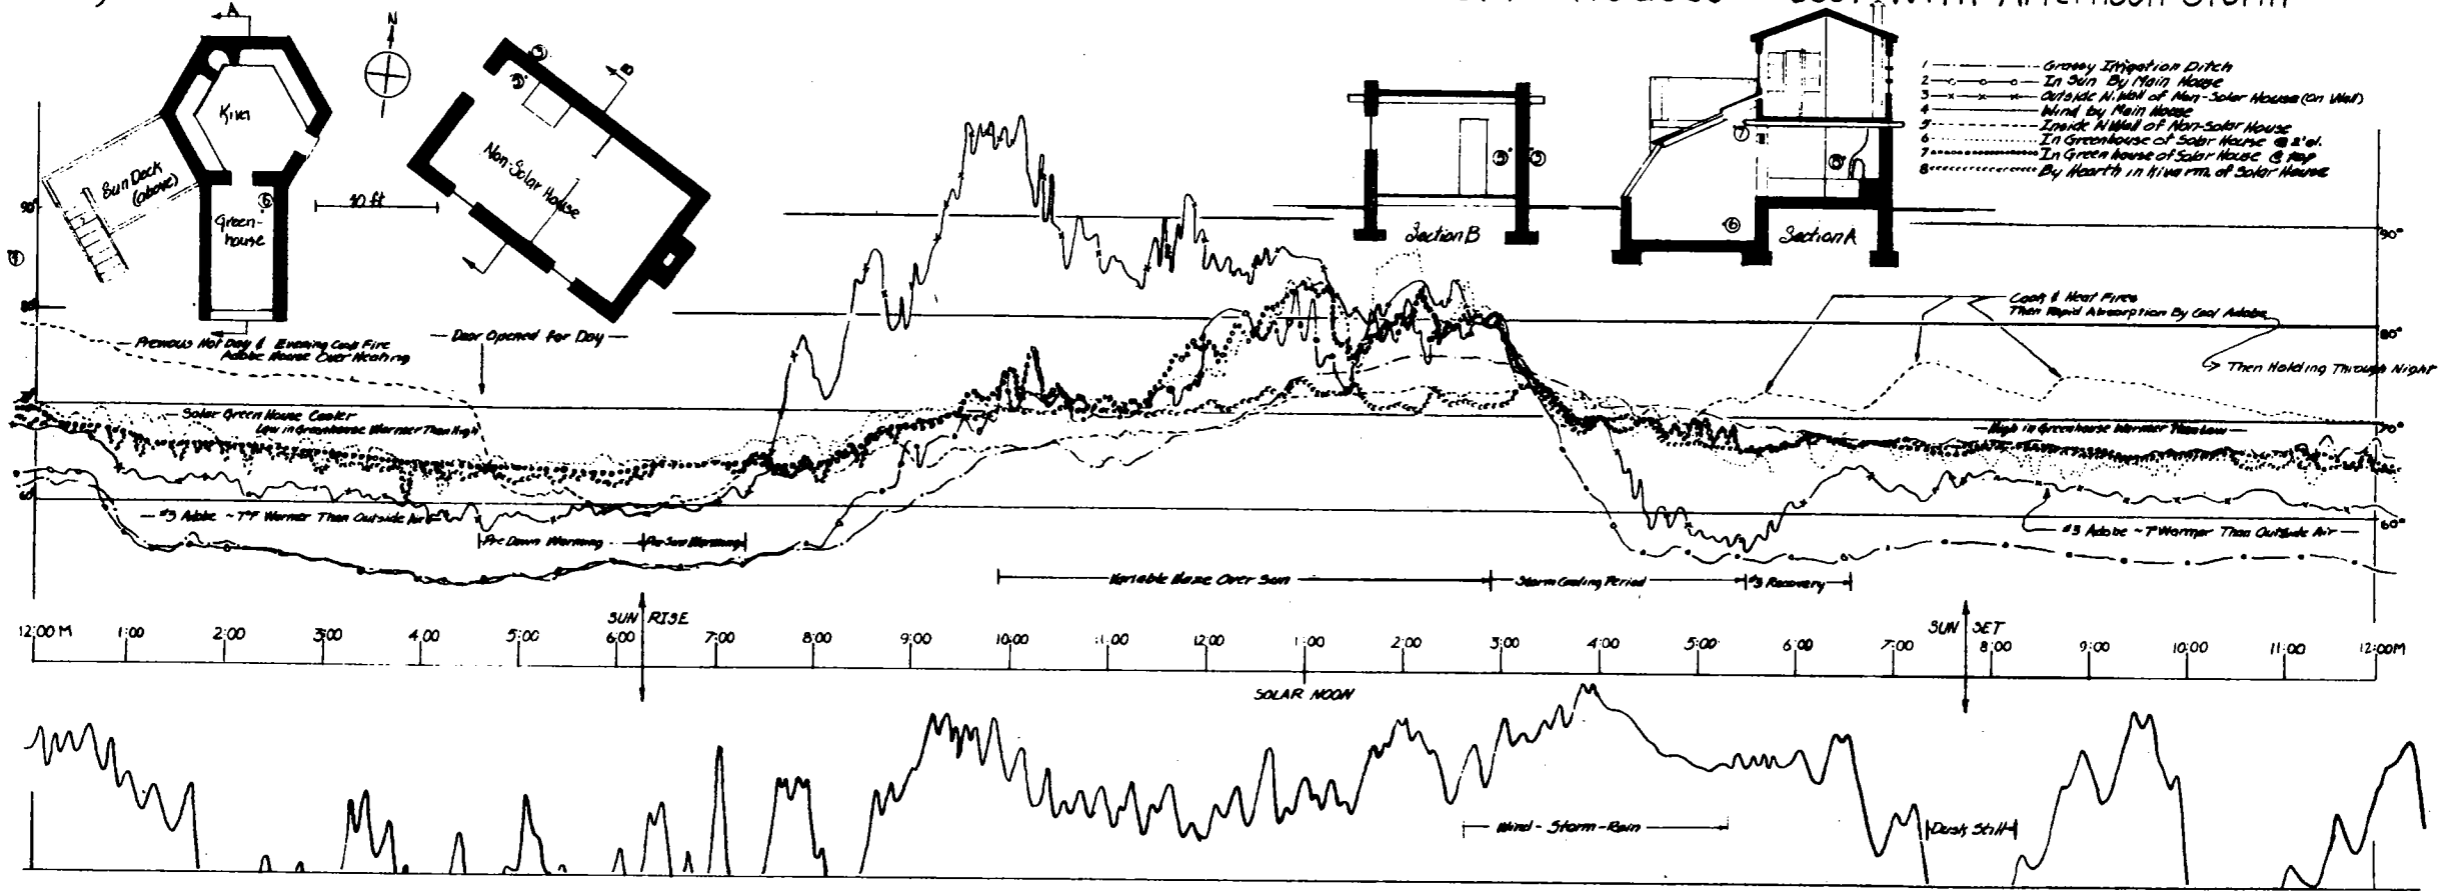
August 1977 - San Luis, New Mexico - Adobe Solar and Non-Solar Houses - Cool with Afternoon Storm

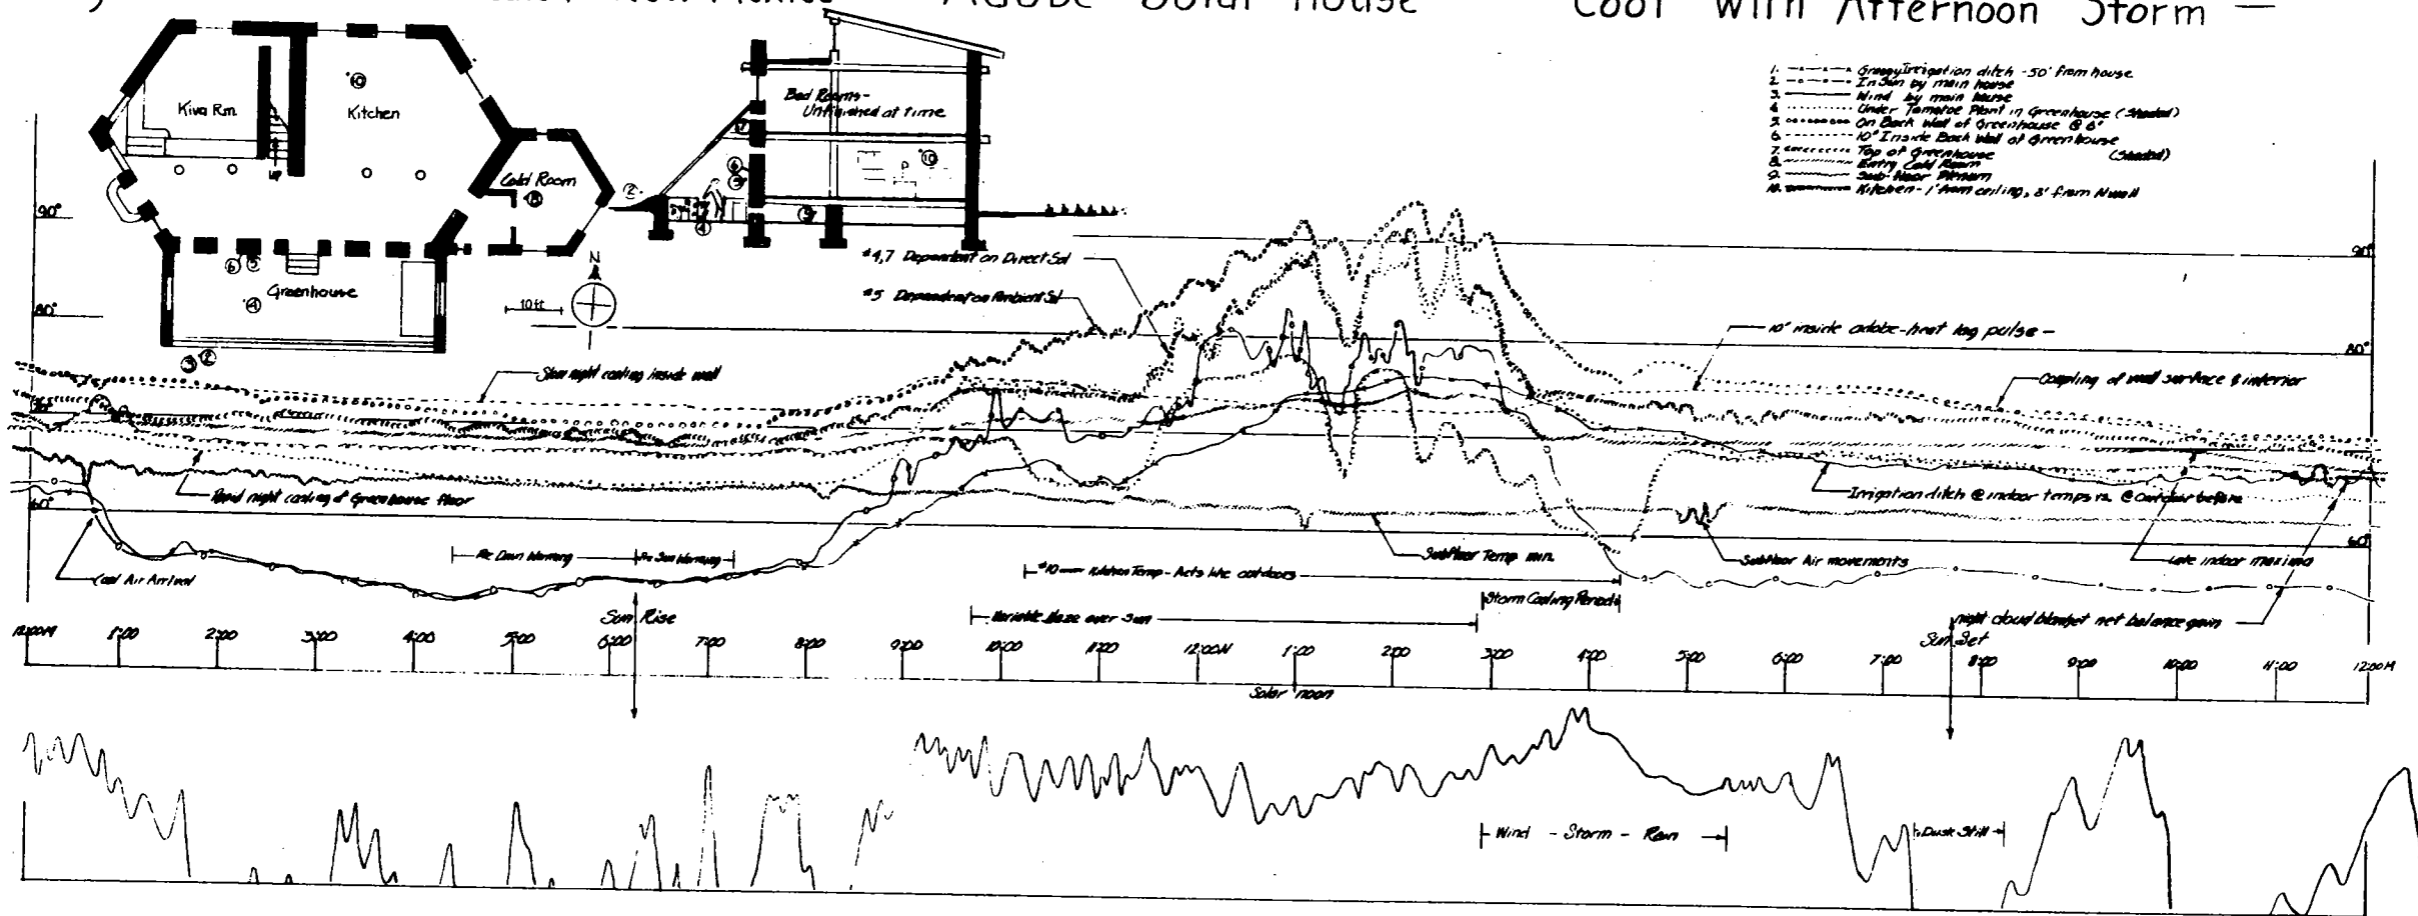
August 1977 - San Luis, New Mexico - Adobe Solar House - Cool with Afternoon Storm -

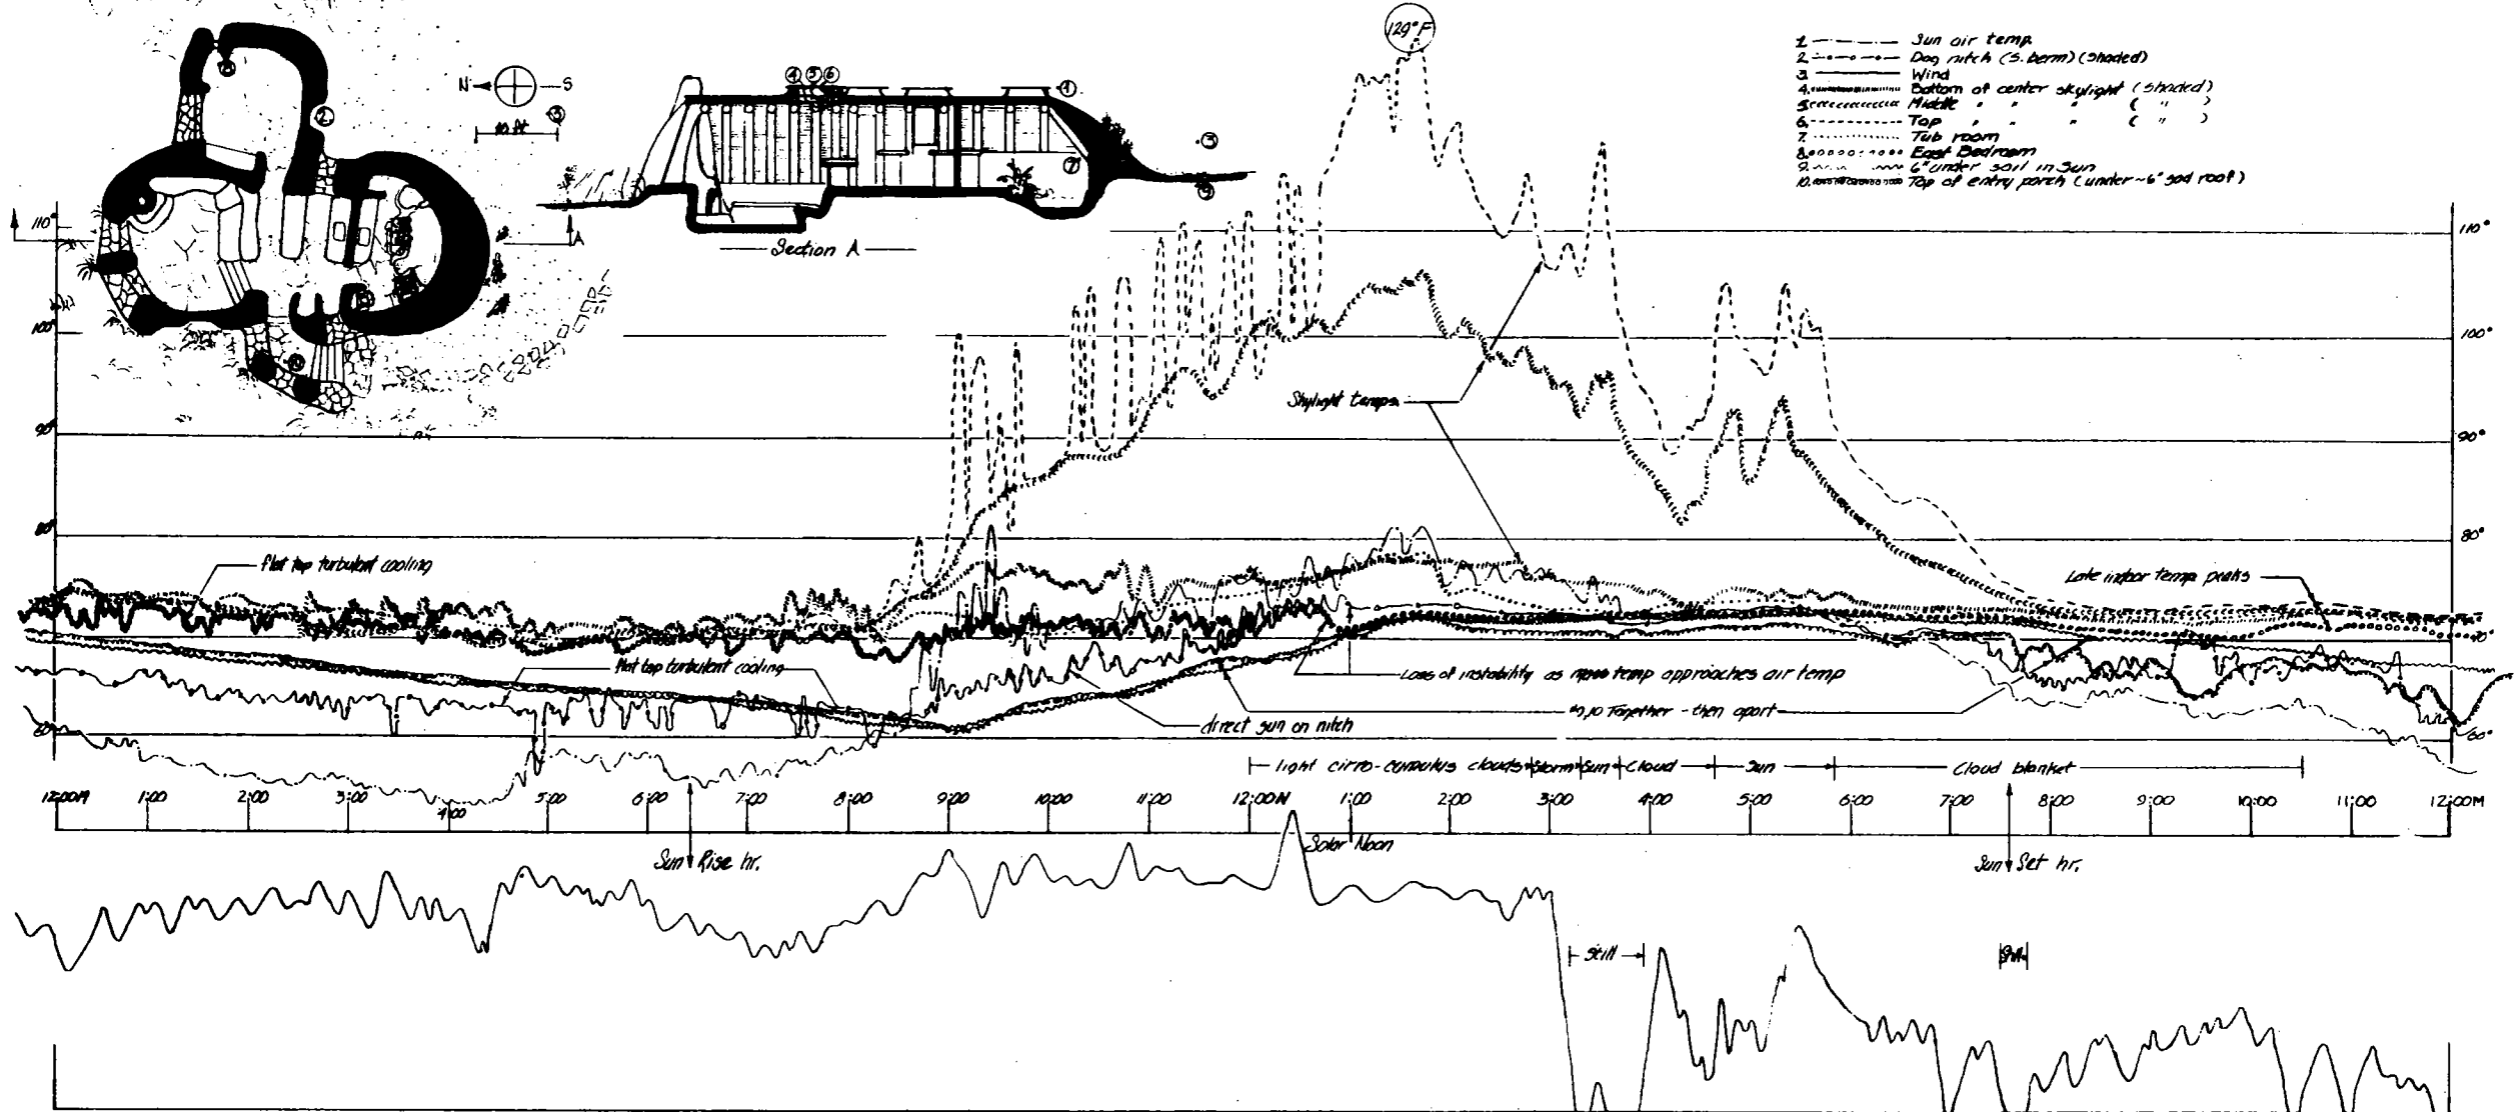
August 1977 - Sante Fe, New Mexico - Adobe Berm House - Partly Cloudy Afternoon

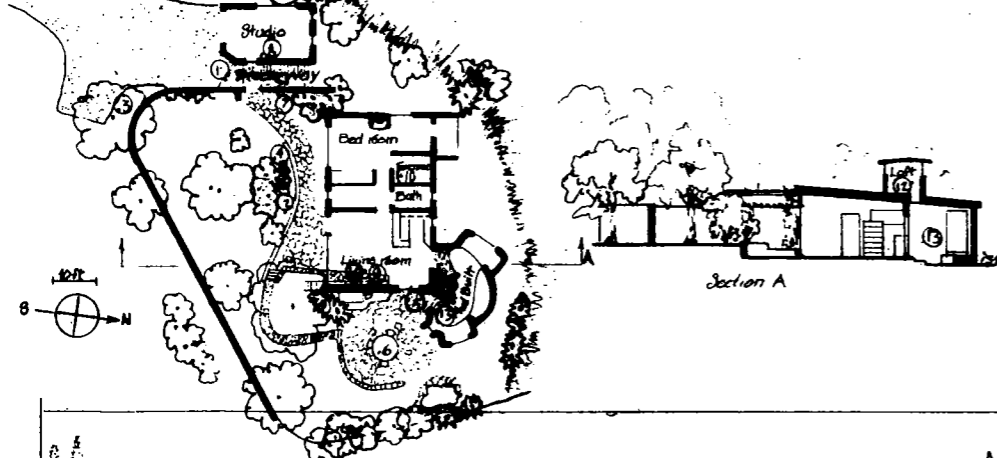
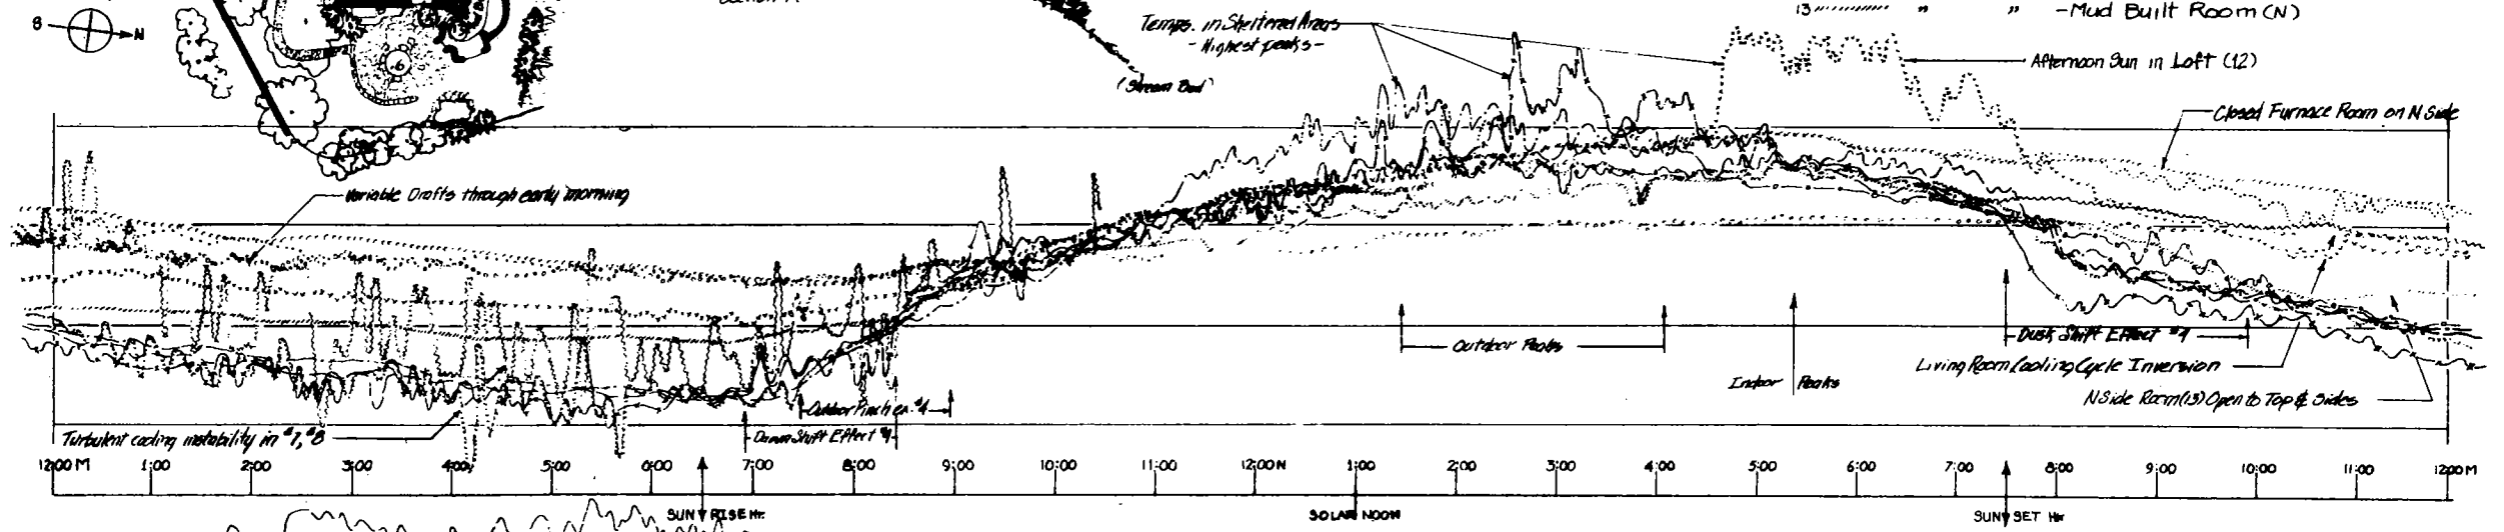
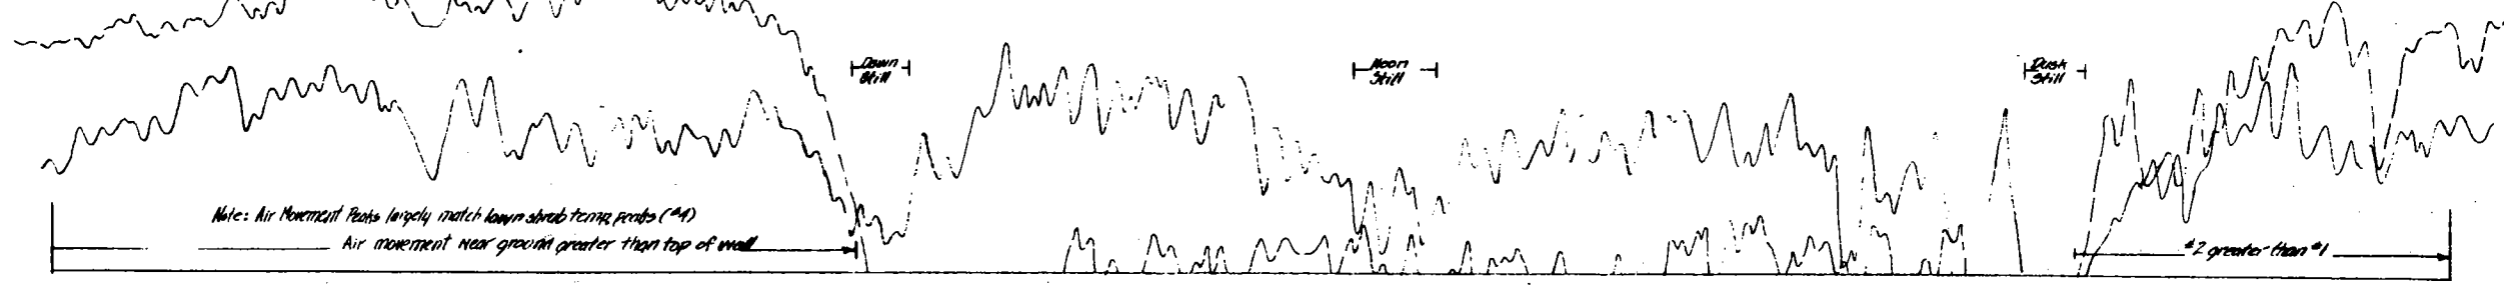
August 31 1977 - Sante Fe, New Mexico - Courtyard Adobe Bungalow - Sunny Day

- 1 ——— Wind - Over Breezeway
- 2 ——— " - On 3' Pole in lawn
- 3 - - - Outside Temp. - Behind Apple Tree in Drive
- 4 - x - x - " " - Shrub In Lawn By Entry Path
- 5 - o - o - " " - Over Patio Door
- 6 - - - - " " - Under Spool Table In Patio
- 7 ~~~~~ " " - Middle Breezeway
- 8 ~~~~~ Inside Temp. - In Studio (garage) by E. Window
- 9 ~~~~~ " " - Over Hearth
- 10 ~~~~~ " " - Base of Hearth
- 11 ~~~~~ " " - Furnace Room
- 12 ~~~~~ " " - Loft Room
- 13 ~~~~~ " " - Mud Built Room (N)
